Teeth are sheared off the timing belt during the starting process or after a short mileage. CT1140K2 and CT1140WP2.

Various diesel engines Euro 6: Opel 2.0; Citroen/ Peugeot 2.0/ 2.2 Blue HDi; Ford 2.0 TDCi / ECO netic / ECOBlue; Toyota 2.0 D4d

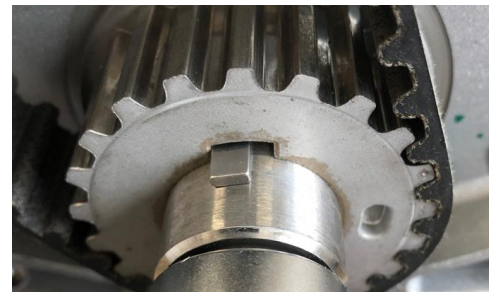
The belt drive is equipped with an oval crankshaft sprocket to reduce power peaks in the belt drive. The crankshaft sprocket is mounted loosely/ movably on the shaft and can be twisted without using the special tool. This, in combination with an incorrectly mounted high-pressure pump, leads to greatly increased force peaks and can cause the timing belt to fail.

Important: When working on the high-pressure pump beforehand, it is essential to ensure the correct installation position!

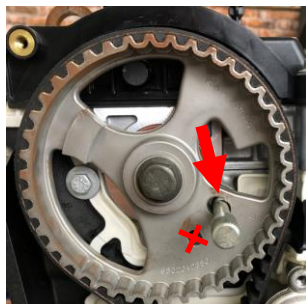
Fig. 1

8mm (Fig. 1) > 1st cylinder TDC for changing the timing belt

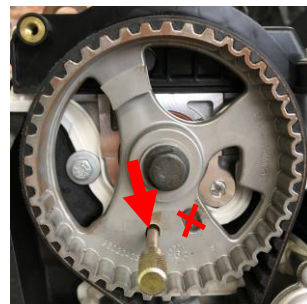
Fig. 2

6mm (Fig. 2) > approx. 75° further, for disassembly and assembly of the injection pump.

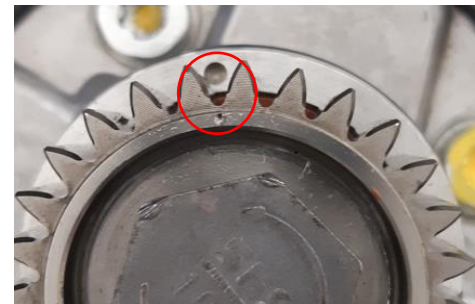
Fig. 3

The high-pressure pump itself has markings on the pinion as well as on the housing (**Fig. 3**), which must be aligned for correct installation. If the high-pressure fuel pump was removed and installed in addition to the timing belt change, first install the timing belt completely and then the high-pressure pump.

If the high-pressure fuel pump was removed and installed in addition to the timing belt replacement, it is essential to ensure the correct installation sequence! First fit the timing belt completely and then the high-pressure pump. The tensioning process must be carried out according to the vehicle manufacturer's instructions, using all the special tools intended for this purpose.

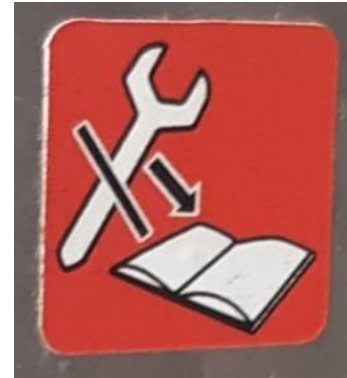
The difficulty is finding the markings. Used pumps are sometimes wetted with black oil on the gear wheel and the special features of this pump are simply not known to many workshops. A sticker on the injection pump indicates that the special installation instructions must be observed.
