Technical *data*

Change of the tension pulley in the kit CT 1045 K1 for Renault 1.2 16 V

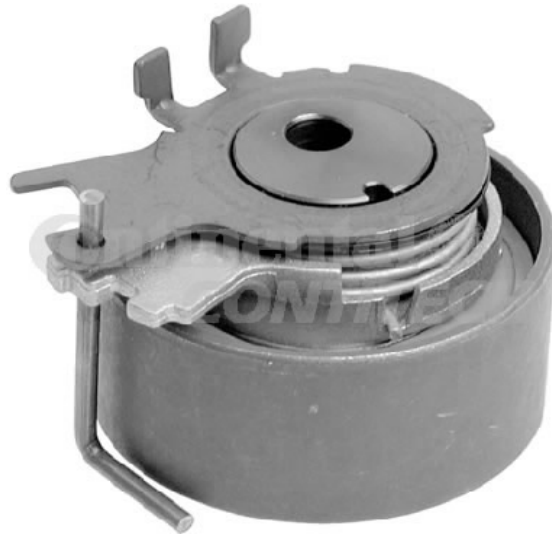
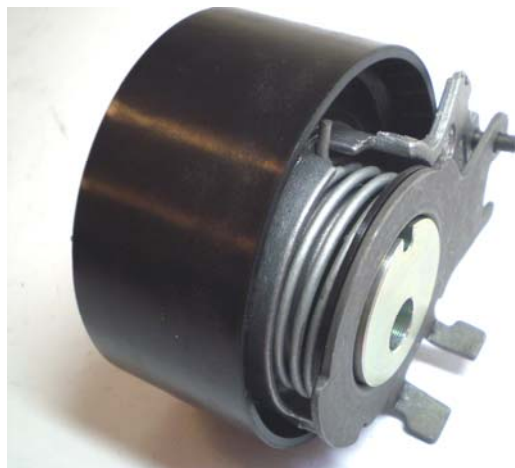
The barrel jacket material of the tension pulley in the kit is different from that of the removed pulley.

The barrel jacket of the tension pulley was changed by the manufacturer from sintered metal to plastic.

The new pulley can be used without limitations.
