Technical *data*

Failure of idler pulley due to blocking of cover layer – CT 1092 K1 (1.6-l diesel; 9H engines in Peugeot, Citroën, Ford, Fiat, Mazda, Mini, and Volvo)

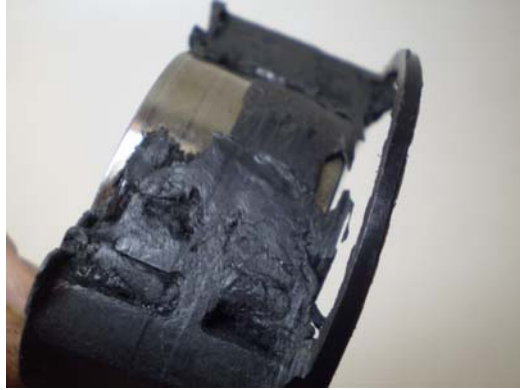
The belt drive fails due to the defective idler pulley. Part of the plastic cover has been ground through.

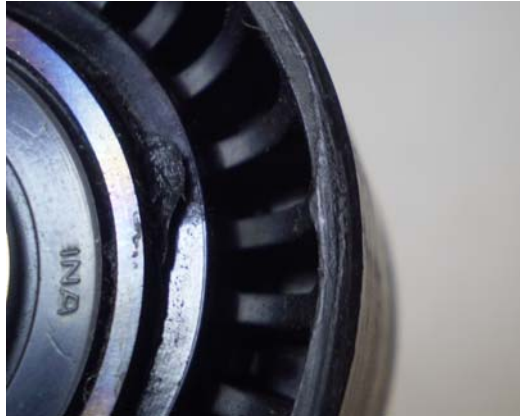
The idler pulley becomes blocked due to non-permissible contact with the cover and fails after a short period due to the belt sliding over the top.
