febi 36634

109394, 173133

Oil Filter, Oil Filter Cap, Oil Filter Housing

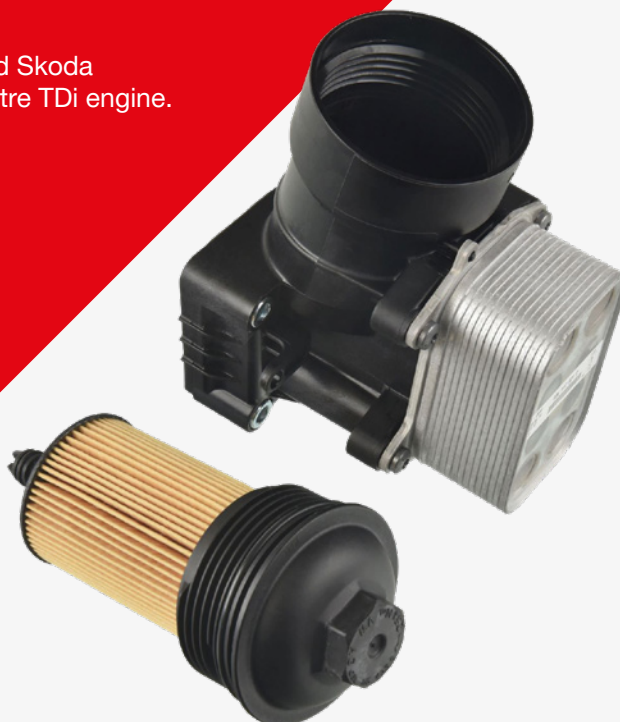
Oil leaking from the engine oil filter housing.

The oil filter cap and housing, which is made from a hard and durable thermoplastic, becomes weak or damaged following repeated unscrewing and tightening. This is most likely to occur if the cap is not correctly aligned, or is over tightened, during the filter element replacement.

When replacing oil filter 36634, inspect the cap and housing for any distortion or damage to the threads. If there is any damage found, replace the cap with 173133 or the complete housing 109394, where necessary.

When replacing and fitting the new filter element, coat the new "O" ring seals (fitted to the cap) with clean engine oil. Insert the cap and filter assembly into the housing and, in a clockwise direction, screw in; tightening to 25 Nm as illustrated on the cap. Fill the engine to the correct level with fresh oil. Following this, start the engine and check for any oil leaks.
