febi 38238

Various Volkswagen, Audi, Seat,
Skoda, and Mitsubishi models

Crankshaft Oil Seal

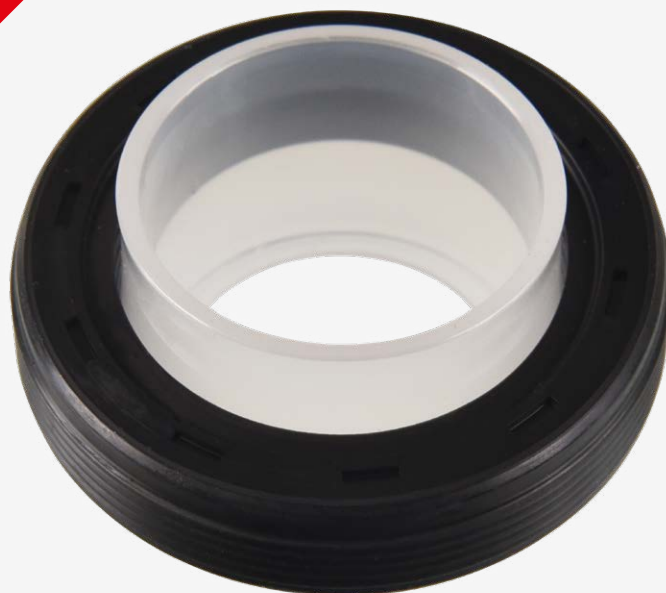
Oil leak after replacement of the crankshaft seal.

When installing this sensitive seal, the sealing lip is easily damaged and the seal does not function correctly.

The febi 38238 crankshaft seal comes complete with a special installation adapter. This is provided to avoid damage to the seal during installation.
