SWAG 30 93 1253

to fit:
VW Polo, VW Golf

Repl. No. 1K0 407 183 E

Suspension arm bush

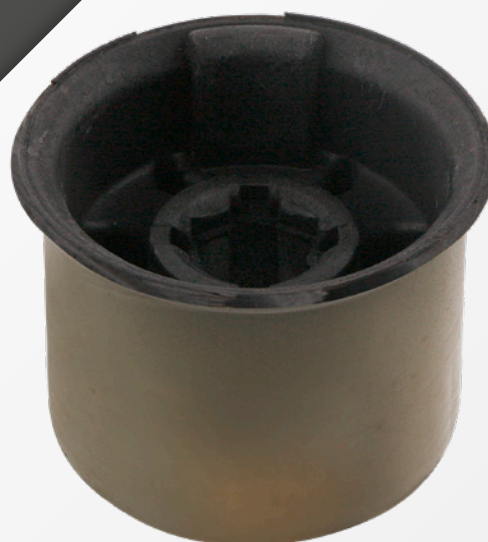
Vehicle manufacturers design suspension arm bushes which are often not strong enough. Their lifetime is also shortened by poor road and weather conditions. The version originally fitted (repl. No. 6Q0 407 183 A) had two rubber bars (Fig. 2) which could tear under unfavourable loads (Fig. 1). This variant has been withdrawn from service at VW and replaced.

1 Faulty suspension arm bush

SWAG recommends using the new suspension arm bush SWAG 30 93 1253 (repl. No. 1K0 407 183 E). The strengthened suspension arm bush has four rubber bars and can withstand large loads even under poor road surface and weather conditions (Fig. 3).
