Blue Print

AD07R1785, AD07R2264

Honda Accord CN1/CN2 2003>08; CR-V RD9/RE6 2005>08; FR-V BE5 2005>08

Auxiliary drive belt

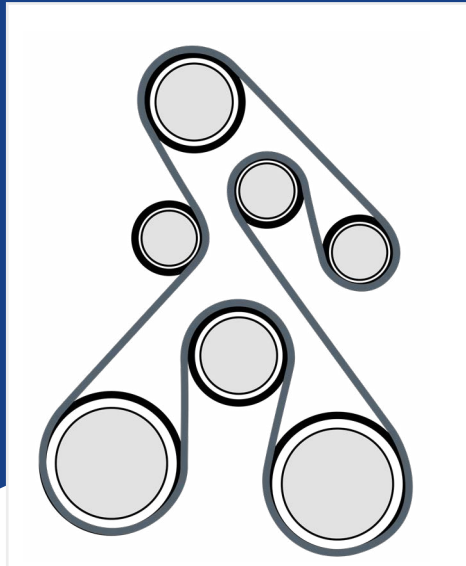
Original routing with 2264 mm belt

Whirring or clicking noise from the engine, which increases with engine speed.

Cause

High load on the alternator drive pulley which causes premature wear of the alternator bearing.

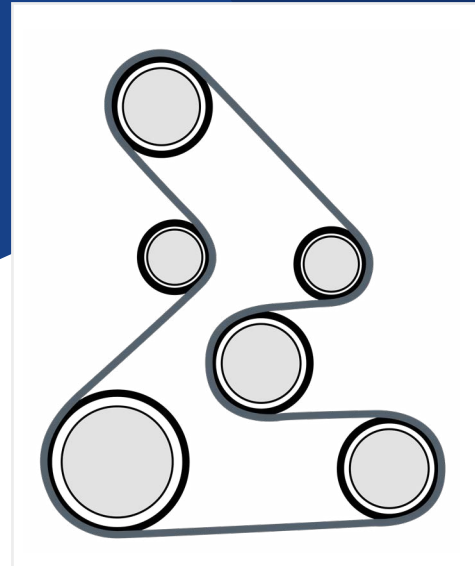
Modified routing with idler removed and 1785 mm belt

Modified auxiliary belt layout, routing and size of the auxiliary drive belt, this is to reduce the stress on the alternator bearings.

The modification involves completely removing the upper idler pulley, and replacing the original 2264mm belt with a shorter 1785mm belt which is re-routed as per the diagram above.

When replacing the auxiliary drive belt it is advisable to check the alternator bearings by rotating the pulley and checking for any roughness or noise, and replacing the alternator if necessary.
