PI 1904
For technical personnel only!
1/2

WARNING ABOUT PRODUCT FAKES

FOR THE VARIABLE INTAKE MANIFOLD ON THE MERCEDES-BENZ M272

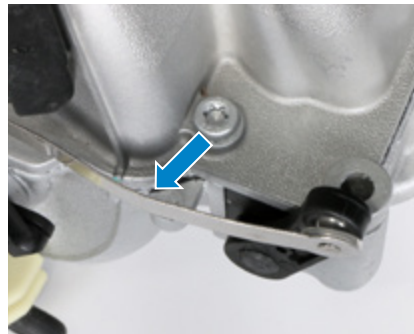
Fig. 3

- “... thin sheet on the cam control mechanism, which bends after a relatively short time (Fig. 3).”
- “The lever springs out of its mounting (Fig. 4). This incorrectly actuates the flap position sensor and can lead to an error message.”
- “The flap bearings can break.” (Fig. 5)
- “Parts can come loose.” (Fig. 6)
- “The linkage makes noises that can clearly be heard during vehicle operation.”
- “Installation of these fakes would represent gross negligence.”

The cause that leads to the cam control mechanism breaking and remedy instructions can be found in our Service Information SI 1455.
