Technical *data*

CT 939 K2/K3 & CT1120K1 timing belt kit, used for example in:
VW / Audi 2.5 TDI 5 cyl.

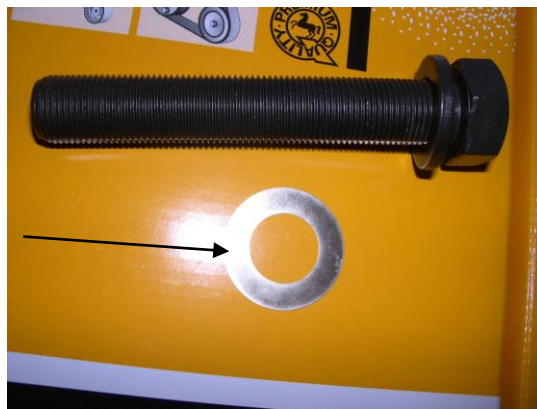
Fig. 1
Washer

In accordance with the updated equipment status, the timing belt kit contains a thin washer (diamond-coated) that was not previously installed in the vehicle.

According to the VW/Audi catalog, this special washer (4) is to be installed between the crankshaft drive wheel (3) and the torsional vibration damper (5). This is intended to improve the co-efficient of friction.
