Timing belt kit

febi no. 14110

**Vauxhall Corsa B, Tigra A, Astra F 1.4 16V
and 1.6 16V, also Vectra B 1.6 16V
and 1.8 16.V except x 1.8 XE (ref. no. 1606 274)**

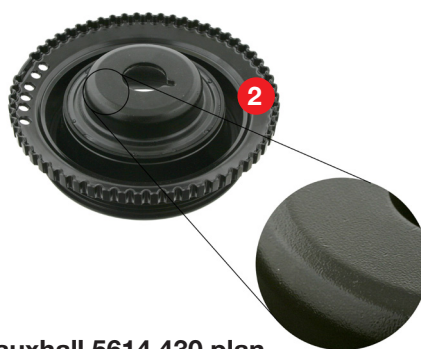
Vauxhall 5614 430 plan

to picture 2) (Vauxhall plan 5614 430). The new belt pulley will fit correctly to the timing belt, thereby guaranteeing a longer life span.

febi bilstein recommends: before fitting the timing belt kit febi 14110, check for a raised part of the belt pulley and, if necessary, replace with the new version (refer
