## SWAG 10 92 1174

to fit:  
Various Mercedes-Benz models

## Rubber Metal Bush for Wheel Bearing Housing

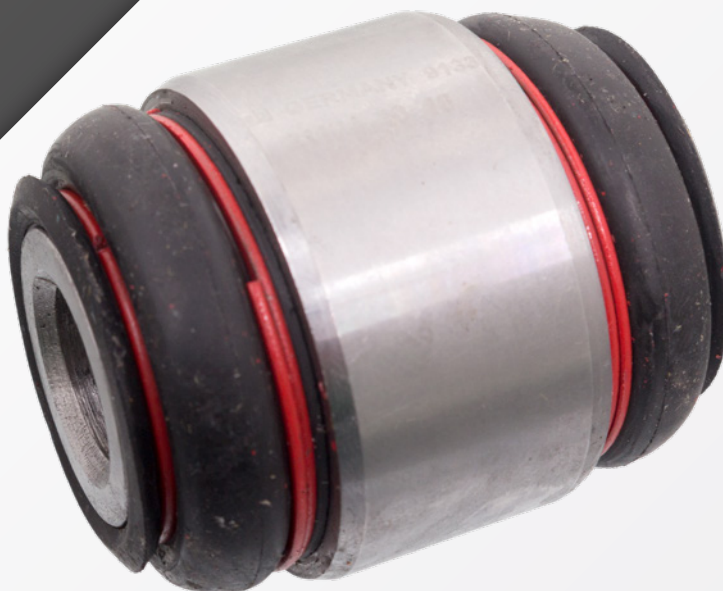
Knocking or creaking noises may be heard from the rear axle area while driving.

The original design of this bush is very susceptible to wear. This stems from insufficient internal lubrication. Wear is accelerated when the vehicle is driven in harsh road and weather conditions.

SWAG 10 92 1174 has been improved. The modified bush has several channels instead of just one. This ensures a permanent supply of lubricant which lengthens the bush's service life.
