## SERVICE INFO – INA 0092

# Optičke razlike klackalica ventila Kat.Br. 422 0053 10

Modeli:	
Audi:	A1, A3
Seat:	Altea, Ibiza, Leon
Skoda:	Fabia, Octavia, Superb
VW:	Eos, Golf IV, Golf Plus, Golf V, Golf VI, Jetta III, Passat (C3_), Polo (6R_), Polo (9N_)
Motori:	1.4 FSI, 1.4 TSI, 1.4 TFSI, 1.6 16V, 1.6 FSI
OE brojevi:	422 0053 10
OE brojevi:	036 109 411 E 036 1 09 411 G 036 109 411 H 036 109 411 J

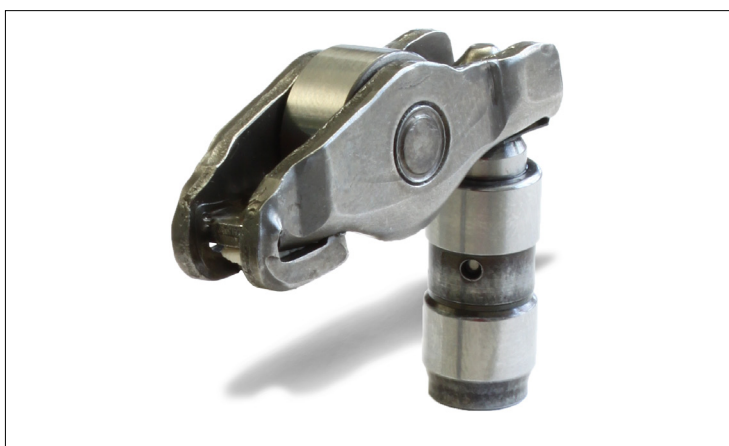
Slika 1: Izvedba 1

Prilikom zamjene klackalica ventila Kat.Br. 422 0053 10, moguće je pronaći ugrađene na vozilu oba dvije izvedbe prikazane na slikama 1 i 2.

Schaeffler Automotive Aftermarket dobavlja izvedbu klackalice ventila prikazanu na Slici 1.

U slučaju kvara na jednoj ili više klackalica ventila, neizostavno je promjeniti sve klackalice ventila. Da bi se izbjegli višestruki popravci i povećani troškovi, uvijek istovremeno zamijenite; klackalica ventila i element za podešavanje zazora ventila za vrijeme servisnog zahvata.
